Manhole Inspection Summary

Manhole # S41C2_002MH

Insp Date: **12/6/07 10:02 AM**

Location Address: **3810 9th St**

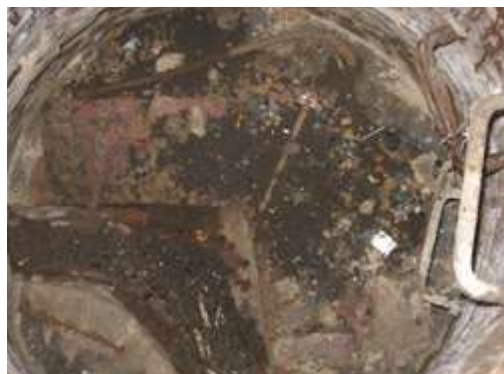
Defect 2

Debris

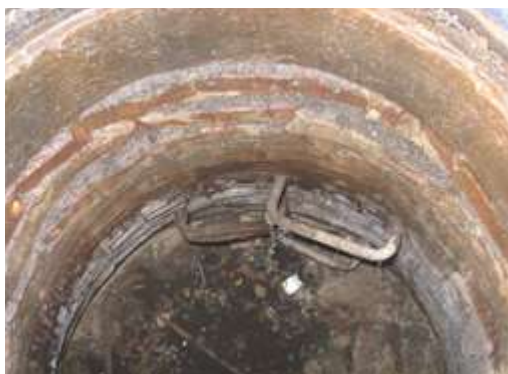
Defect 1

Offset: **1** (in.)

Frame offset

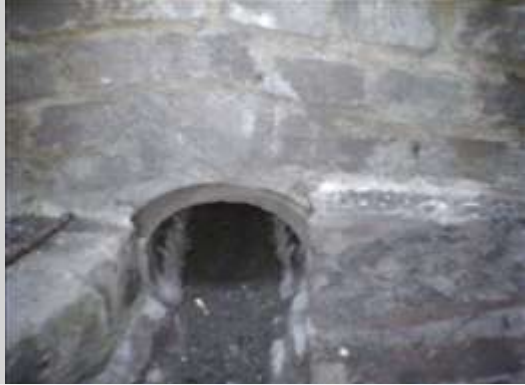
12 O'Clock Outflow

8 in. Circular Gravity Sewer
Pipe Out @ 12 O'Clock

Pipe Height: **9.6** (in.) Rod and Bar (Angled)
Pipe Material: **Clay** ☐ Pipe Lined
Invert Depth: **7.88** (ft.) Flow Characteristics: **None**
Deposits: ☒ None ☐ Mud ☐ Sludge ☐ Debris ☐ Grease
Silt Depth: (in.) Deposits Extent:
Infiltration: **None** Pipe Seal Cond: **Sound**

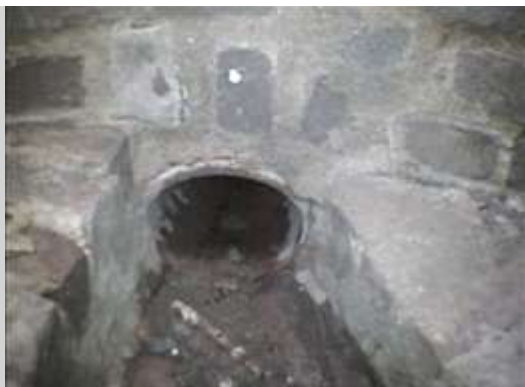
9 O'Clock Inflow

6 in. Circular Service Sewer
Pipe In @ 9 O'Clock

Pipe Height: **7.2** (in.) Rod and Bar (Angled)
Pipe Material: **Clay** ☐ Pipe Lined
Invert Depth: **7.65** (ft.) Flow Characteristics: **None**
Deposits: ☒ None ☐ Mud ☐ Sludge ☐ Debris ☐ Grease
Silt Depth: (in.) Deposits Extent:
Infiltration: **None** Pipe Seal Cond: **Sound**
